Precision Home Inspections, LLC

Property Inspection Report

LMNOP Road, Happy, CO 81500
Inspection prepared for: Inspector Daily
Real Estate Agent: Crystal Zimmerman - One Stop Realty

Date of Inspection: 8/20/2019 Time: 8:00
Age of Home: 26 Size: 6300
Weather: Clear

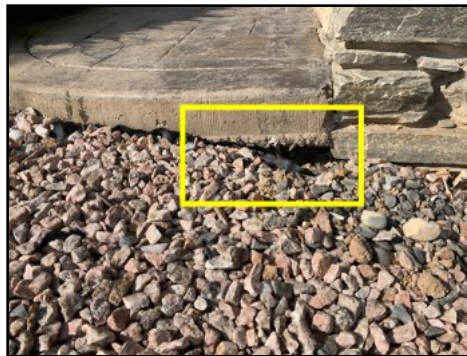
- At the time of the inspection, few deficiencies observed in the condition of the walkways. Notable exceptions will be listed in this report.
- Common cracks (1/4-inch or less) were visible in the walkways. Cracks exceeding 1/4 inch should be filled with an appropriate material to avoid continued damage to the walkway surface from freezing moisture.
- Trip hazards in the walkways appeared to be the result of the expansion or contraction (heaving or settling) of underlying soil. This condition should be corrected by a qualified contractor.

Undermining of soil beneath east aspect of front walkway

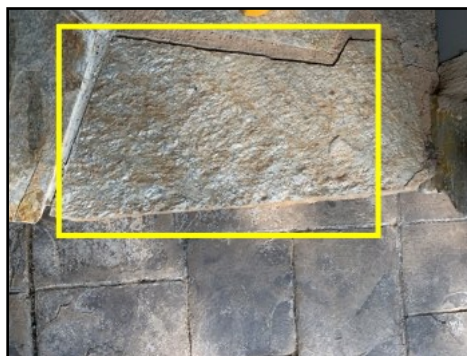
Loose stone observed at stoop to ADU unit

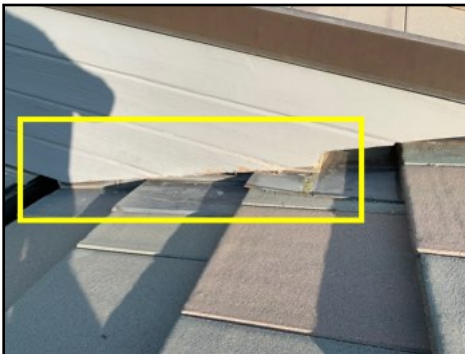
- Deterioration of the lower portions of wood siding covering exterior walls appeared to be inadequate clearance from the roof-covering material.
- Good building practice requires a gap of 1.5 inches minimum between the bottom of exterior wall-covering material and the top of the roof-covering material to avoid damage from decay caused by moisture absorption.

Wood cladding covering the exterior walls at south/west aspect has inadequate clearance from roof covering, showing signs of damage

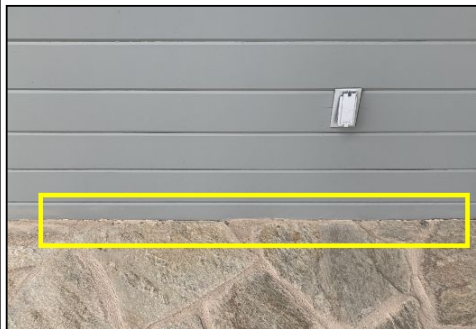
- Wood siding covering exterior walls had inadequate clearance from grade. This condition may result in damage to lower courses of shingles from wood decay caused by moisture absorption. Wood siding should have a minimum clearance of 6 inches from grade.

Inadequate clearing from grade at north patio

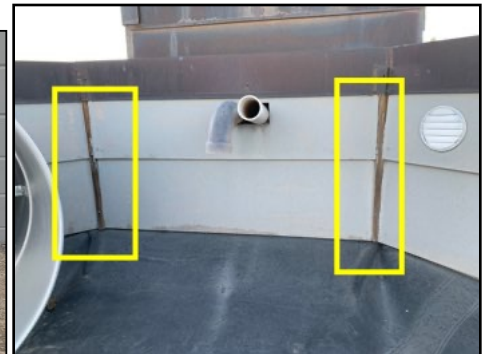
- Deferred painting maintenance at north. I recommend repair as needed.
- At the time of the inspection, no deficiencies observed in the condition of artificial stone veneer covering exterior walls. Inspection of artificial stone typically includes examination of installation practices and visible condition.

Deferred paint maintenance

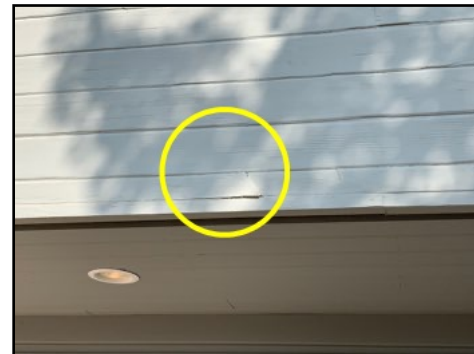
- Areas of loose or sagging wood siding covering exterior walls indicated failure of the fastening method. Wood siding in these areas should be re-fastened or replaced to prevent damage to the siding and to prevent potential damage from moisture intrusion to the home materials, the exterior wall structure and to prevent development of microbial growth such as mold. All work should be performed by a qualified contractor.

Loose wood cladding at south garage

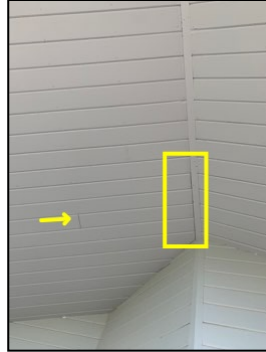
- Few deficiencies observed in soffit or fascia at the time of the inspection. Notable exceptions will be listed in this report.
- Deferred caulking maintenance at front covered entrance. I recommend repair as needed.
- FYI: All exterior painted surfaces should be annually examined and sealed, re-caulked and re-painted as needed.

Deferred caulk maintenance at front covered entrance

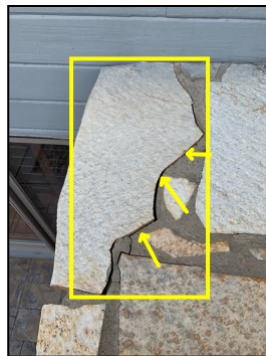
- Few deficiencies observed in the condition of the fences at the time of the inspection. Notable exceptions will be listed in this report.
- Loose cap stone observed at west retaining wall. Repair as needed.

Loose stone at west retaining wall

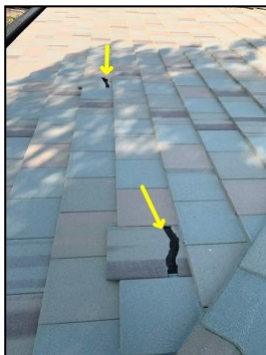
Cracked/broken tile at southern slope

Page 11 Item: 3	Roof Covering	<ul style="list-style-type: none"> The roof had cracked and/or broken cement roof tiles that should be replaced to help prevent damage from moisture intrusion to the home materials, the roof structure and to prevent development of microbial growth such as mold. I recommend that you consult with a qualified contractor to discuss options and costs for repairs. Roof ridge cap tiles were loose, displaced, or missing at the time of the inspection. This condition appeared to be due to failed mortar bond, which means that the mortar bonding other ridge cap tiles to the roof is weak. The Inspector recommends an evaluation and any necessary work be performed by a qualified roofing contractor.
Page 12 Item: 4	Flashings	<ul style="list-style-type: none"> The home had no kick-out flashing installed where walls extended past roof edges. Kick-out flashing is designed and installed to divert water from behind the exterior wall covering at areas of the home where a sidewall extends out past a connecting roof eave. This condition may allow moisture intrusion of the exterior wall covering. Moisture intrusion of the wall structure can damage home materials and encourage the growth of mold. Long term moisture intrusion can cause structural damage from wood decay. I recommend that you consult with a qualified roofing contractor to discuss options and costs for replacement.

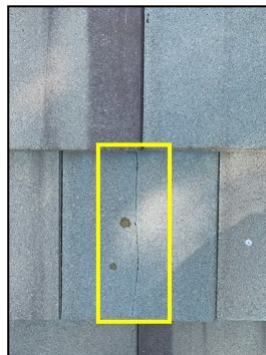
Cracked tile at south/east

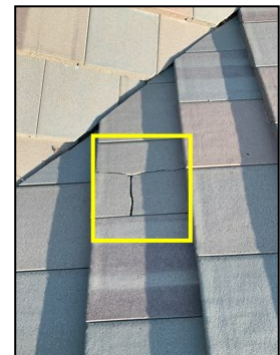
Broken tile at south/western slope

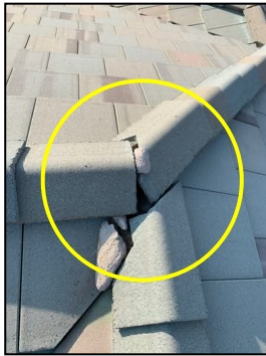
- Roof ridge cap tiles were loose, displaced, or missing at the time of the inspection. This condition appeared to be due to failed mortar bond, which means that the mortar bonding other ridge cap tiles to the roof is weak. The Inspector recommends an evaluation and any necessary work be performed by a qualified roofing contractor.

Ridge cap installed at south/west has left gaps exposing roof to moisture intrusion

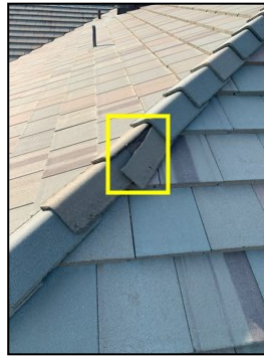
Broken ridge cap at north/east hip

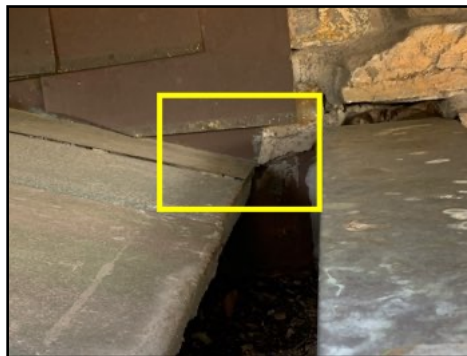
The home had no kick-out flashing installed where walls extended past roof edges. Kick-out flashing is designed and installed to divert water from behind the exterior wall covering at areas of the home where a sidewall extends out past a connecting roof eave. This condition may allow moisture intrusion of the exterior wall covering. Moisture intrusion of the wall structure can damage home materials and encourage the growth of mold. Long term moisture intrusion can cause structural damage from wood decay. I recommend that you consult with a qualified roofing contractor to discuss options and costs for replacement.

Kick - out flashing absent at south/east

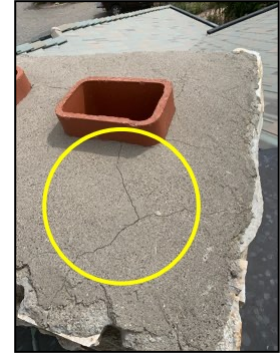
- Satisfactory installations, appeared functional at time of inspection.
- Venting appeared serviceable.
- Moderate cracking visible in the chimney cap should be filled with an appropriate sealant to prevent worsening damage caused by moisture in the cracks expanding as it freezes. All work should be performed by a qualified contractor.
- IMPROVE: The chimney(s) had no spark arrestor. I recommend that all chimneys have an approved spark arrestor installed by a qualified contractor to prevent pest entry and to help protect the roof-covering materials from potential chimney-source ignition.

Moderate cracking of chimney cap-south

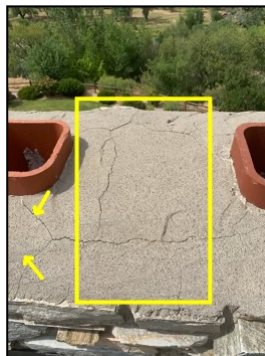
Moderate cracking of chimney cap – north

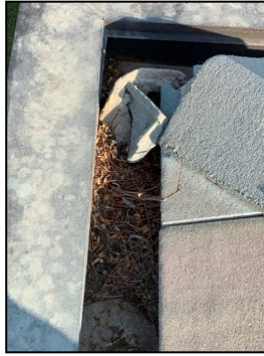
Dirt/debris observed in gutter at north/west aspect

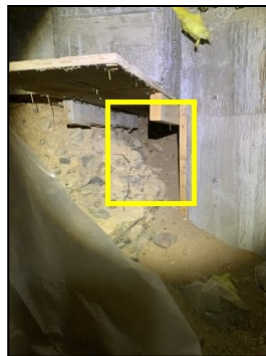
• In a basement or crawlspace, digging too close to the foundation footings can compromised the Cone of Compression. The Cone of Compression is the area of soil beneath a foundation that supports the weight of the foundation and the home structure above. This soil should remain undisturbed to avoid compromising its structural integrity. The profile of the weight-bearing soil beneath the foundation is roughly cone-shaped, sloping down and out from the bottom corners of the foundation footing at an angle of approximately 45 degrees. This condition can lead to undermining of the foundation and loss of foundation support leading to structural failure in the affected areas. Inspectors should identify such areas and mention whether they observe signs of failure connected to this condition, and that the possibility for future damage exists. Recommend that the client consult with a structural engineer or qualified foundation contractor to determine the necessity, options and costs for stabilization.

Loose soil beneath footing at south/west

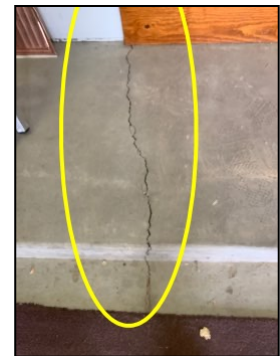
Crack observed at stoop in garage, signs of displacement

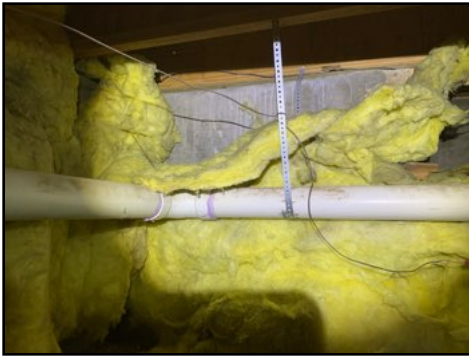
Loose insulation at north/east aspect

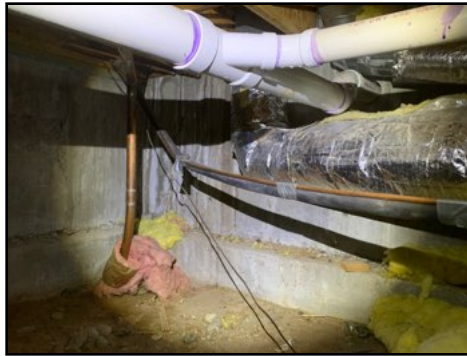
Loose/absent insulation at south/east

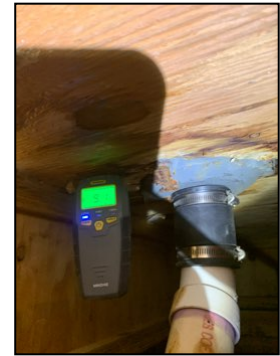
A low level of active moisture was present beneath shower #1 as indicated by moisture meter during the time of inspection

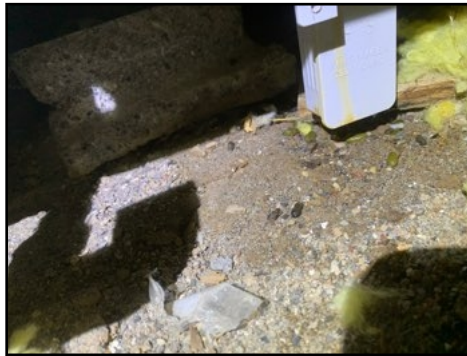
- FYI: Evidence of rodent droppings in crawlspace and attic. I recommend consulting pest professional for further evaluation.

Rodent droppings beneath crawlspace furnace

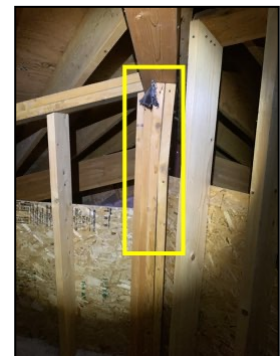
Inadequate support of hip rafter at south/west

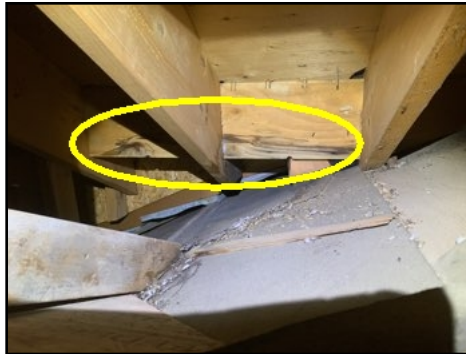
- Access located in garage.
- Access located in Bedroom #3 closet.
- No deficiencies noted.
- Dry moisture stains observed at south/east valley (signs of prior roof leaks).
- Inspector could not safely enter or fully view - ducting, insulations and architectural design prevented full access and inspection.

Dry moisture stains observed at south/east valley

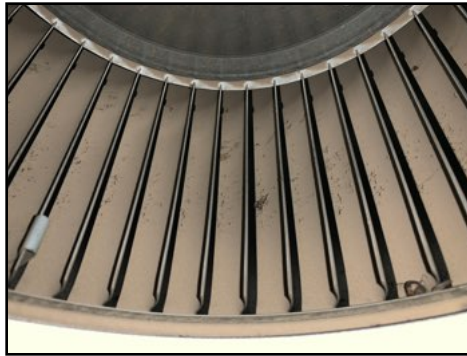
- Dirty furnace blower vanes visible at the time of the inspection should be cleaned to avoid blower damage and increased operation costs. I recommend service by a qualified heating service technician.

Furnace in mechanical room blower vanes, appear dirty

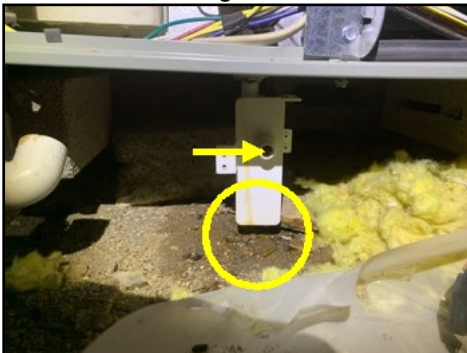
Exhaust condensation for crawlspace furnace is disconnected and leaking

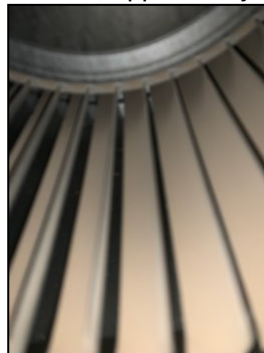
Crawlspace furnace blower vanes, appear dirty

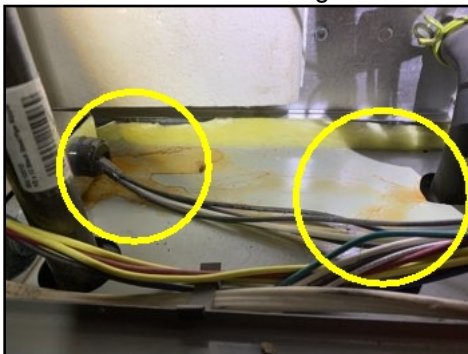
Rust observed in burner compartment of crawlspace furnace

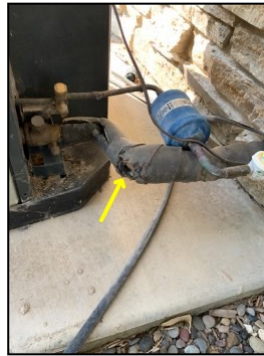
Insulation on A/C condenser unit refrigerant line at north is damaged

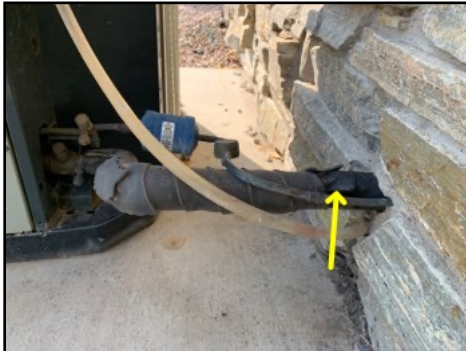
Insulation on A/C condenser unit refrigerant line for south unit is damaged

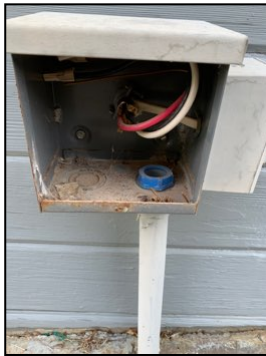
- Visible wiring appeared functional.
- Miscellaneous abandoned wiring visible in at north and east should be evaluated by a qualified electrical contractor to determine whether any wiring is still energized. Improperly terminated, energized wiring is a shock/electrocution hazard.
- Exposed wiring observed at north lower level. All exposed active wiring under 8' or at exterior of home is required to be in the appropriate conduit material (recommend repair by qualified licensed electrical contractor).

Abandoned electrical wiring at north/west aspect

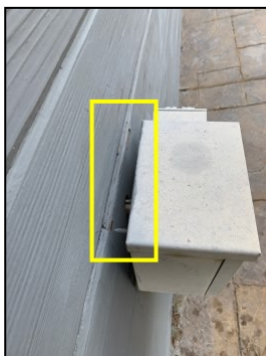
Junction box at west exterior is improperly fastened

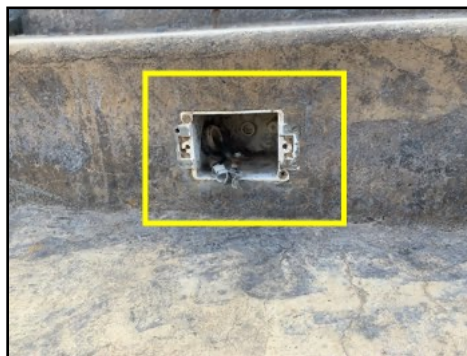
Exposed junction box at rear exterior stairwell

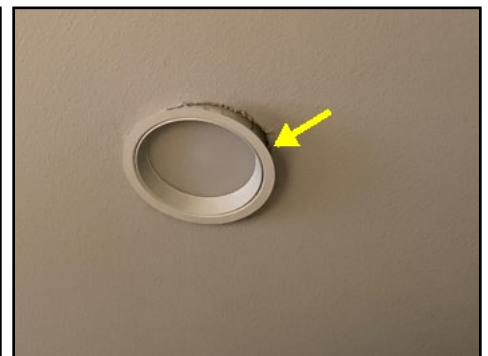
Loose light fixture above shower in bathroom #3

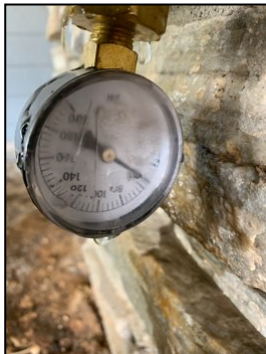
- Hose bib at south and west of house leaks from valve while under pressure.
- Hose bib at west of house is loose from structure. Recommend corrections be made by licensed plumbing contractor.

South exterior hose bib

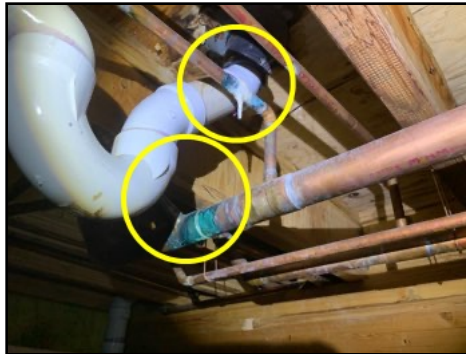
Heavy corrosion observed on water supply pipes in crawlspace beneath shower #1

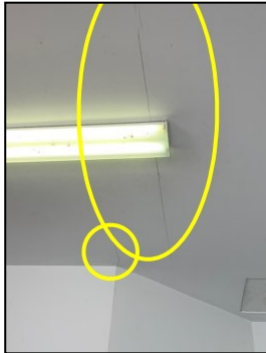
- Wall and ceiling finishes are in satisfactory condition.
- No evidence of water intrusion observed.
- Some cosmetic, common small cracks and typical flaws in drywall finish noted. This is normal wear for age of home.
- Unusual crack pattern at garage ceiling, bedroom #1 ceiling and south living room ceiling. This can be considered normal for the age of the home (recommend monitoring, attention or repair).

Unusual crack pattern at garage ceiling

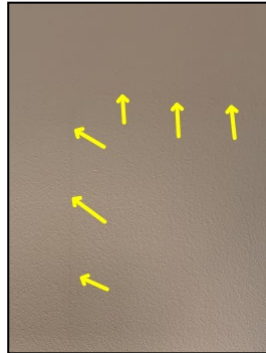
Unusual crack pattern at ceiling in front entrance

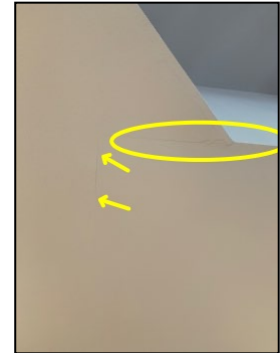
Unusual crack pattern at south/west living room

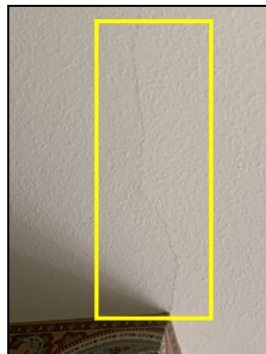
Unusual crack pattern at bedroom #1 ceiling

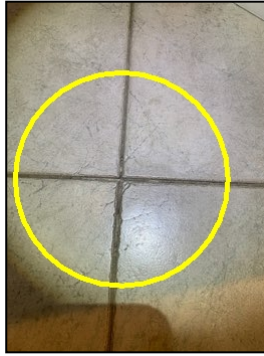
- Floor coverings are in satisfactory condition. Appearance of normal wear and age
- Cracked grout observed near garage service door.

Cracked grout observed near garage service door

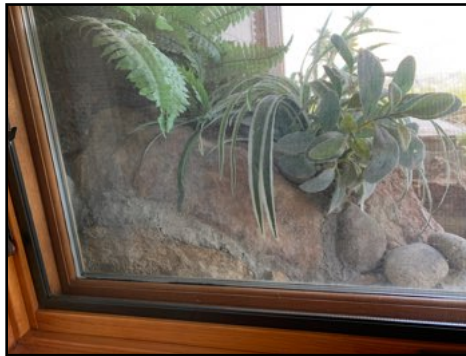
- Few deficiencies observed in the condition of windows at the time of the inspection. Notable exceptions will be listed in this report.
- Window(s) at North/west living room does not operate as expected. The water feature at the exterior of the home is blocking window from opening.

Water feature obstruction at north/west living room window

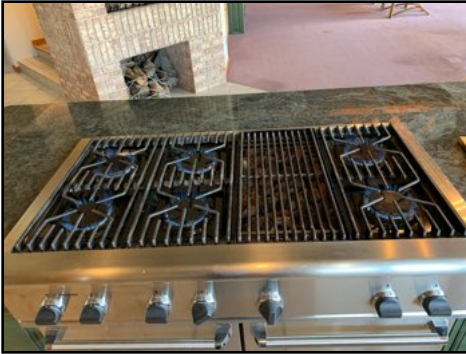
Cook - top

- The middle burner did not operate as expected during the time of inspection. Repair as needed.
- Oven(s) operated when tested.

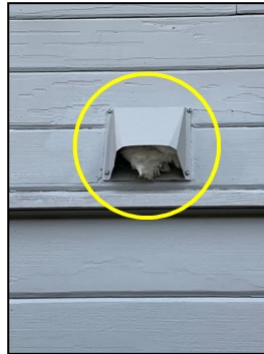
Clogged dryer vent at west
