456 1st Street, Grand Junction, CO 81501 Inspection prepared for: John Smith Real Estate Agent: Always Available - Consider it Sold, LLC

Date of Inspection: 4/18/2022 Time: 8:00 Age of Home: 112 Size: 1245 Weather: Clear

Inspector: Ben Gare NACHI#18042422 Phone: 507-202-3333 Email: inspectgj@gmail.com inspectgj.com

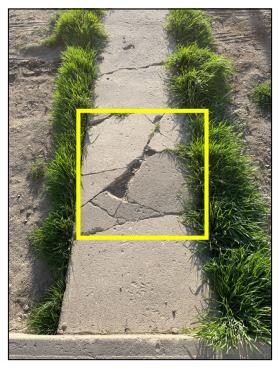
- The walkways were badly damaged or deteriorated and appeared to at or near the end of their useful lives at the time of the inspection.
- Severe heaving of soil beneath the walkways had created trip hazards that should be corrected by a qualified contractor.
- The walkways were severely deteriorated. I recommend that you consult with a qualified contractor to discuss options and costs for correction.

Severe heaving observed

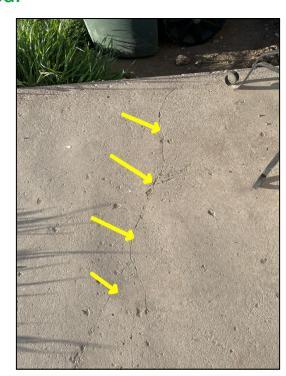
• At the time of the inspection, few deficiencies observed in the condition of the front stoop. Notable exceptions will be listed in this report. • The concrete stoop had shrinkage cracks. Shrinkage cracks commonly occur as newly-placed concrete dries, especially at high-stress areas like

corners. Shrinkage cracks are surface cracks that are not a structural concern.

Shrinkage crack observed

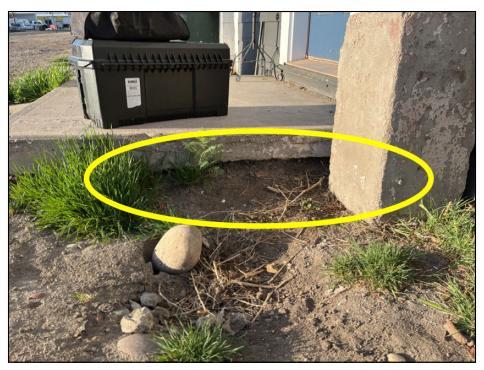
Signs of settlement and improper drainage toward the home at the front stoop.
The undermining of soil beneath the concrete stoop at the front entrance was observed. This condition may lead to settling and cracking at the location of the loose soil. I recommend correction by a qualified contractor to avoid future damage.

Undermining of soil beneath front stoop

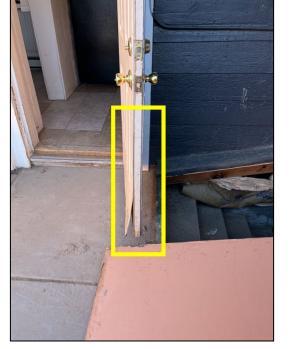
· A door at thesouth entrance had severe damage. I recommend that you consult with a qualified contractor to discuss options and costs for replacement.

Severely damaged door at south entrance

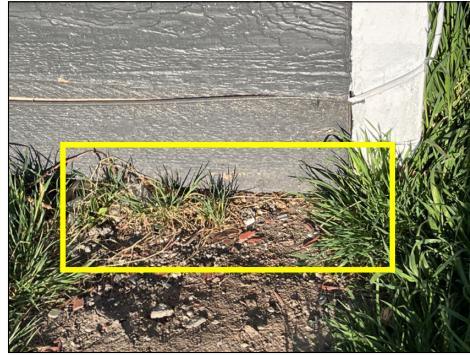
· Composite siding had inadeguate clearance from grade. This condition may result in damage to lower courses of siding from moisture absorption. The manufacturer recommends maintaining a minimum of 6 inches from grade. I recommend re-grading areas of the home where this condition exists to comply with the manufacturer's recommendations.

Inadequate clearance from grade north/east

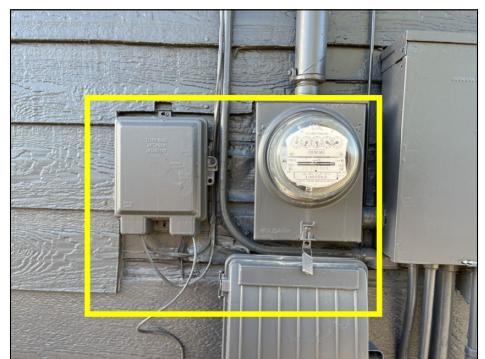
Pipes penetrating exterior walls left gaps that needed to be sealed with an appropriate sealant to prevent moisture and insect entry.
FYI: It is recommend sealing holes & gaps in the siding to keep water infiltration from causing further damage.
FYI: All exterior painted surfaces should be annually examined and sealed, re-caulked and re-painted as needed.
FYI: Approximately 3/4 of the homes built before 1978 (about 64 million homes) contain some lead-based paint. For more information, refer to the following EPA Fact Sheet: http://www.hud.gov/offices/lead/library/enforcement/fs-discl.pdf

Gaps were left where pipes penetrated Composite siding missing at electrical service meter

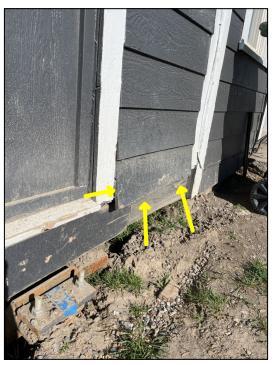
· Loose or sagging composite siding boards appeared to be the result of poor installation practices. I recommend correction by a qualified contractor. • Areas of missing composite siding covering exterior walls indicated failure of the fastening or installation methods. Composite siding in these areas should be re-fastened or replaced to prevent damage to the siding and to prevent potential damage from moisture intrusion to the home materials, the exterior wall structure and to prevent development of microbial growth such as mold. All work should be performed by a qualified contractor. • At the time of the inspection, the composite siding covering exterior walls in areas exhibited severe deterioration. It appeared to be adequately protecting the structure at the time of the inspection.

Loose siding observed at east

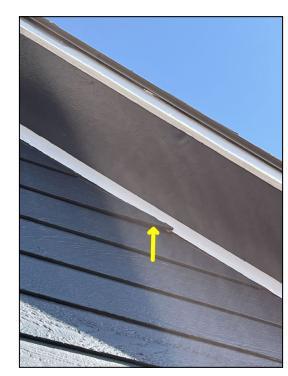
Loose siding observed at south

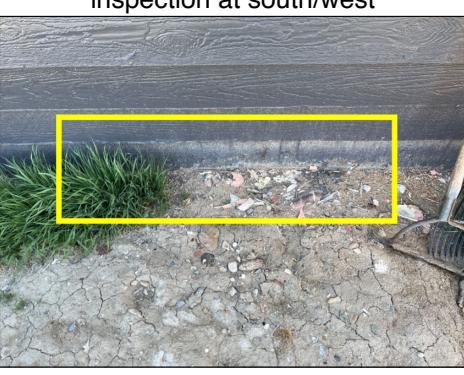
Inadequate clearance from grade at west

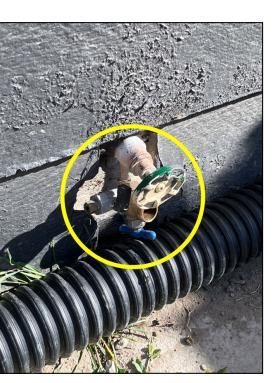
Absent siding at south exterior hose bib

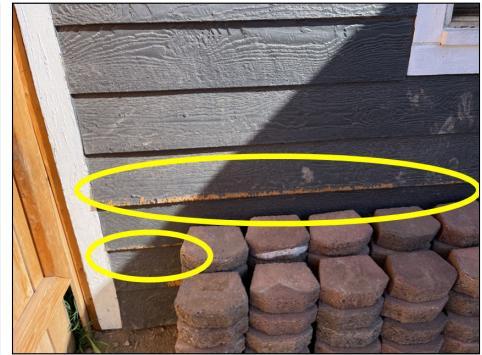
Severely deteriorated siding observed at south/west

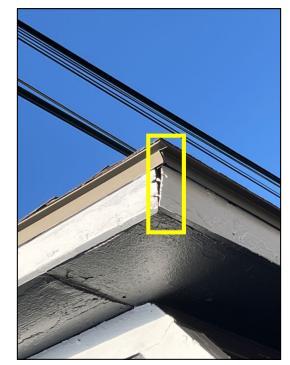
- Deferred sealant maintenance at areas around the home. I recommend repair as needed.
- · Deferred painting maintenance at south/west. I recommend repair as needed.

Deferred sealant maintenance at north/east

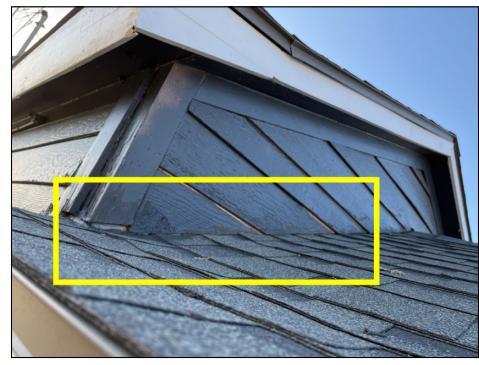
- Loose fascia trim observed at north/west. Recommend fastening to avoid potential pest/moisture intrusion.
 Composite fascia trim exterior walls terminated too close to the roof-covering material. Good building practice requires a gap of 1.5 inches minimum between the bottom of exterior wall-covering material and the top of the roof-covering material to avoid damage from deterioration caused by moisture absorption.

Inadequate clearance from roof covering at west

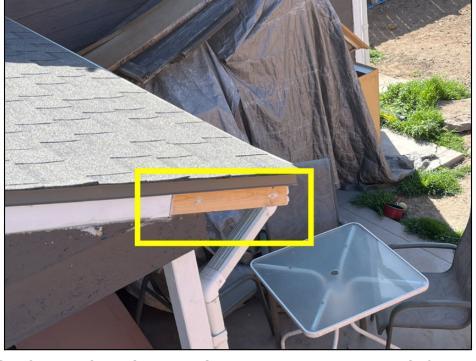
Deferred paint maintenance at south/west

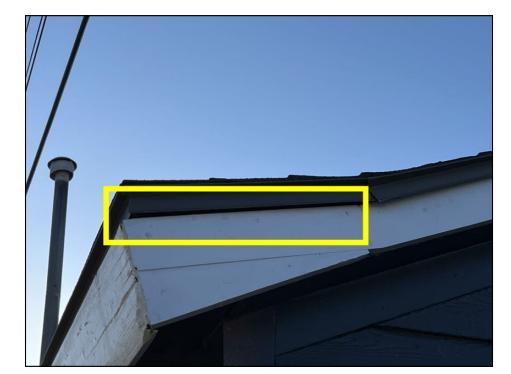
- · Few deficiencies observed in soffit or fascia at the time of the inspection. Notable exceptions will be listed in this report.
- The inspector observed areas around home where the fascia trim was installed exposing the sub-structure of the home. Recommend repairs/replacement to avoid moisture related damage.

Gap in fascia trim observed at north/west

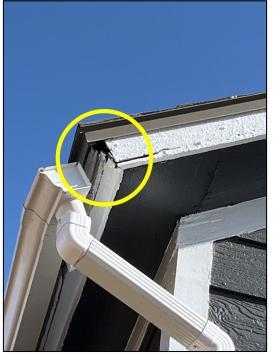
· Damaged fascia trim observed at north/west and south/west. Recommend replacement to avoid potential moisture intrusion and subsequent damage.

Damaged fascia trim at south/west

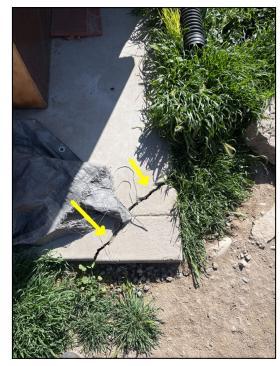
• At the time of the inspection, few deficiencies observed in the condition of the patio or flatwork. Notable exceptions will be listed in this report. · Significant cracks visible in the patio flatwork at the time of the inspection should be filled with an appropriate material to avoid continued damage to the walkway surface from freezing moisture.

Significant crack observed at south/west patio

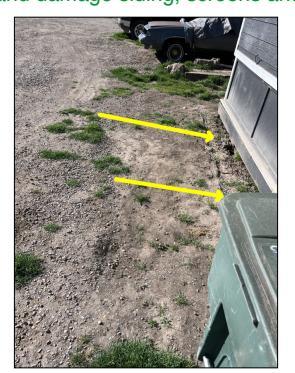
• Few deficiencies observed in the grading and surface drainage at the time of the inspection. Notable exceptions will be listed in this report. • The home had areas of neutral or negative drainage that will route runoff from precipitation toward the foundation. I recommend re-grading these areas to improve drainage near the foundation and help reduce the risk of foundation damage. The ground should slope away from the home a minimum of 1/4-inch per foot for a distance of at least six feet from the foundation.

Negative slope towards home at south/east

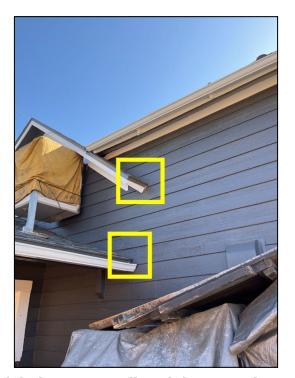
Absent kick - out flashing observed at Damaged roof edge flashing observed Absent kick - out flashings observed at west

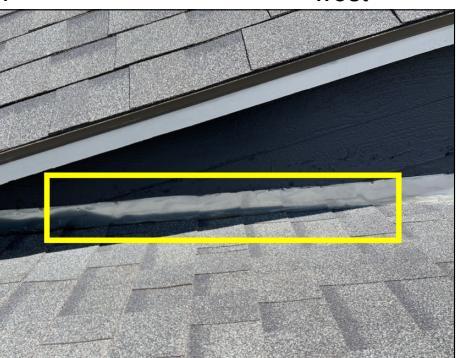
Improperly installed side-wall flashing at south/east

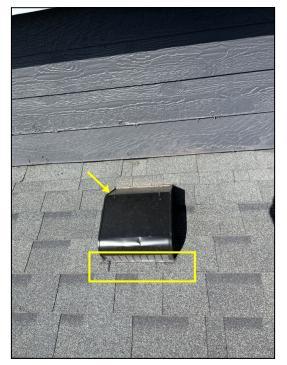
Roof ventilation, improperly installed

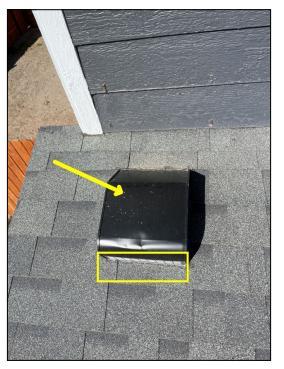
Roof ventilation, improperly installed

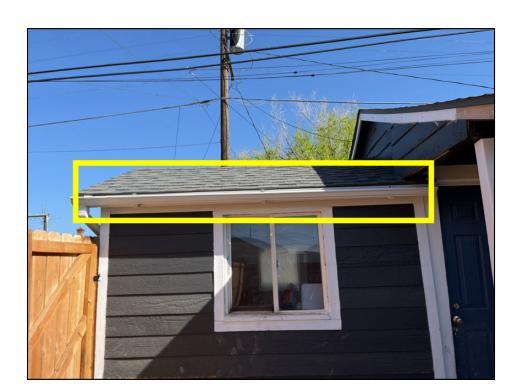
Improper slope at south aspect of north/west storage

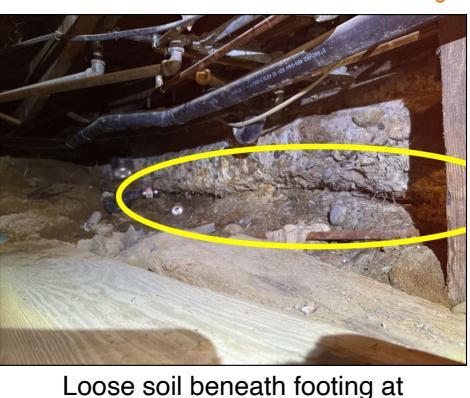
Severely deteriorated at north

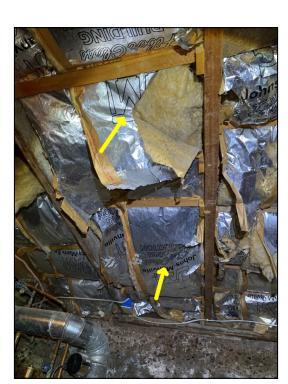
Page 17 Item: 2	Crawl Space	Insulation installed in the basement had paper or foil backing facing the wrong direction. Thermal insulation should always be installed with the paper or foil backing toward the source of heat. Reversal (backing on the cold side) may result in problems from the formation of excessive condensation. Excessive condensation may cause damage to home materials from decay or result in the development of microbial growth which can cause health problems, sometimes serious problems, in some people. At the time of the inspection, the Inspector did not observe any problems which in the inspector's experience could be directly related to this condition. Severe efflorescence observed at basement. While mostly cosmetic (in some cases it can lead to spalling and weakening of the concrete structure). This is an indication of high moisture levels in the crawl space (recommend consulting qualified licensed contractor).

Improperly facing insulation in basement

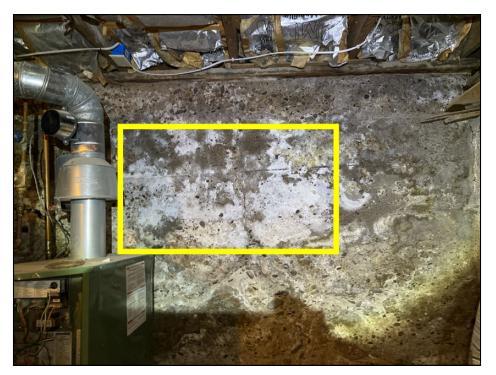
Severe efflorescence observed at north basement

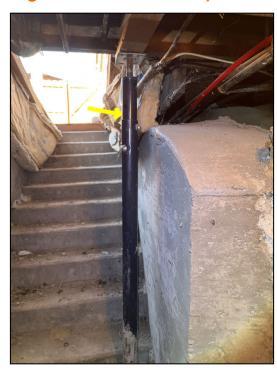
• Telescoping columns have been used as permanent structural supports. These supports are typically considered temporary (recommend review by qualified licensed framing contractor and repair as needed).

Telescoping column observed at bottom of basement staircase

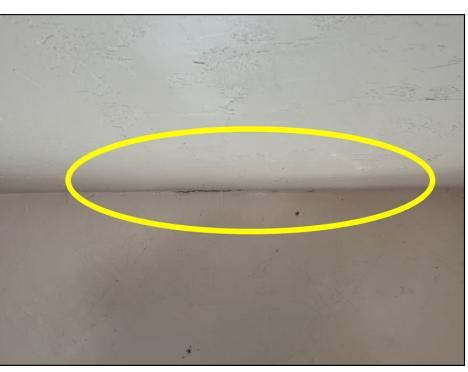
Crack observed at wall - ceiling intersection of north/east bedroom #3

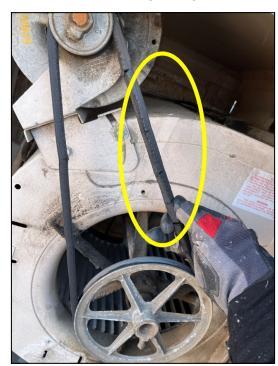
Drive belt, needs replacement

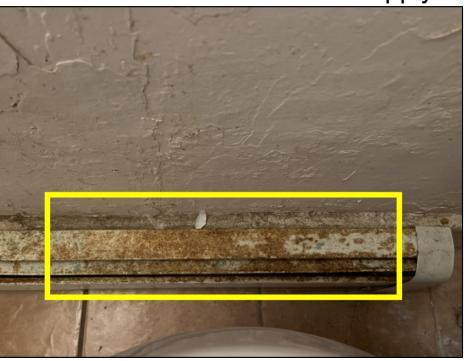
Corrosion observed on register in bathroom #1

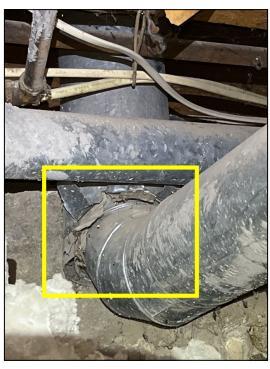
• The exhaust flue of this gas-fired boiler vented into a chimney flue which served an unsealed chimney. This condition may deteriorate the chimney lining and allow the toxic products of combustion (such as carbon monoxide) to enter the living space. I recommend correction by a qualified HVAC or plumbing contractor.

Damaged/improperly fastened boiler vent pipe in basement

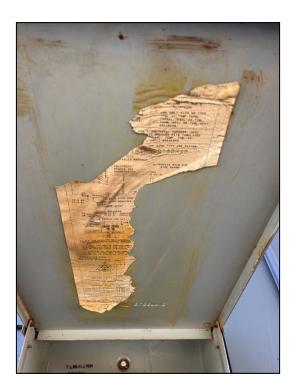
Damaged/illegible data plate

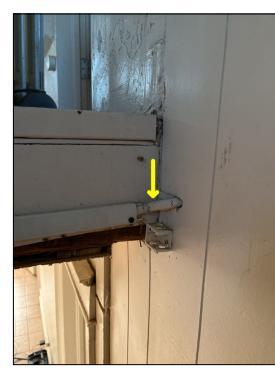
• Exposed wiring observed at staircase and areas around basement. All exposed active wiring under 8' or at exterior of home is required to be in the appropriate conduit material (recommend repair by qualified licensed electrical contractor).

Exposed electrical wiring at top of staircase

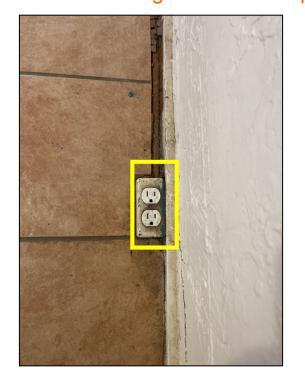
Absent covers at in-floor receptacles in bedroom #1

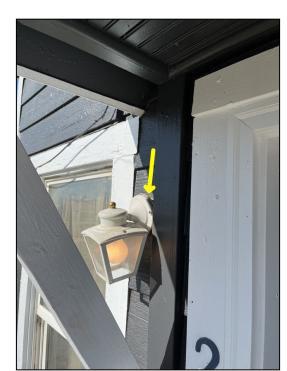
Loose exterior light fixture at front entrance

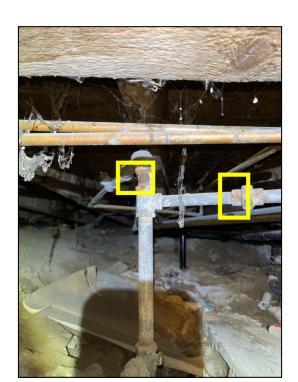
Corrosive pipe fittings observed at south

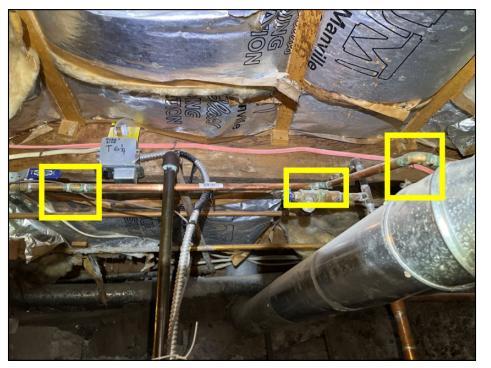
Heavy corrosion observed on water pipe fittings in basement

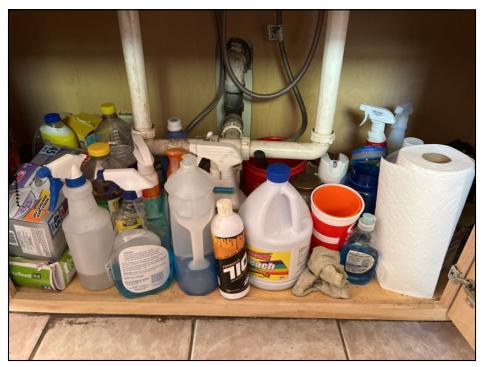
- No deficiencies observed, except where noted.
 The fixtures and drains that water was run through showed functional drainage.
- Restricted view below sinks due to personal items.
- The hot & cold water supplies are reversed at kitchen sink. This is not a functional problem but to someone who is not familiar with this condition unexpected hot water could scald them. We suggest contacting a qualified plumbing contractor to repair.
 Repairs observed beneath kitchen sink. This could be an indication of prior leak. Recommend proper repairs by a licensed plumbing contractor.

Personal storage blocked visual inspection beneath kitchen Sealant repair observed on waste drain plumbing beneath sink

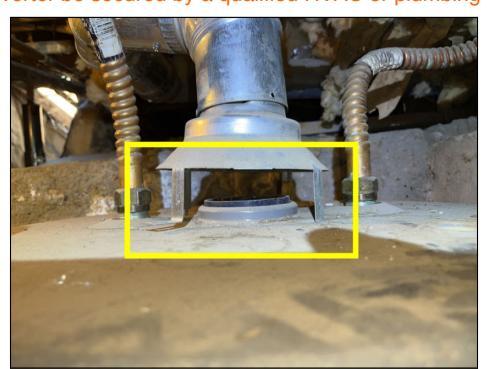
Improperly fastened draft diverter

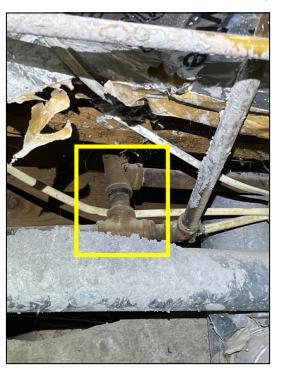
· Gas pipes in the basement/crawlspace had inadequate support which may cause them to leak. I recommend additional gas line supports be installed A gas leak detected at a fitting in the basement should be corrected immediately by a qualified plumbing contractor.

Moderate corrosion observed on gas pipes at west basement

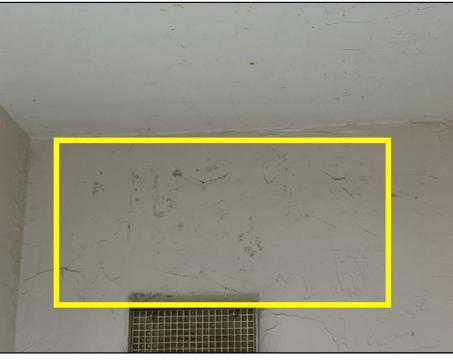
• There is mold/mildew stains at west bathroom #1. This is typically from excessive moisture in bathrooms and not using exhaust fans enough to remove moisture or humidity. Recommend cleaning surfaces with a detergent and painting.

Mold/mildew stains observed near ceiling in west bathroom #1

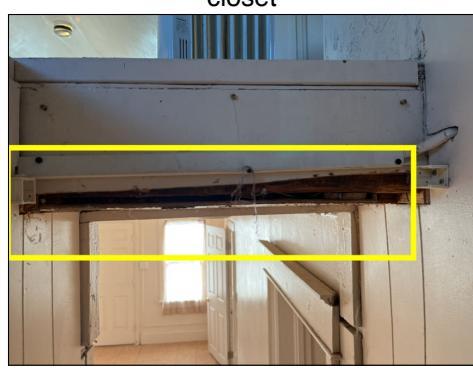
Damaged wood paneling observed at top of staircase

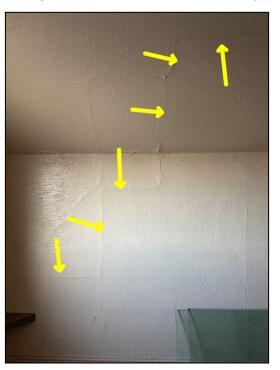
Unusual crack pattern at west wall and ceiling in bedroom #2

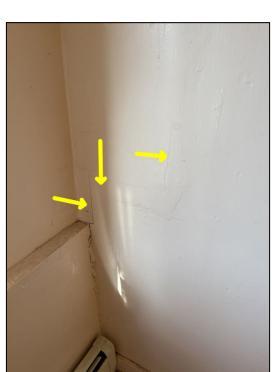
Unusual crack observed at south bedroom #1

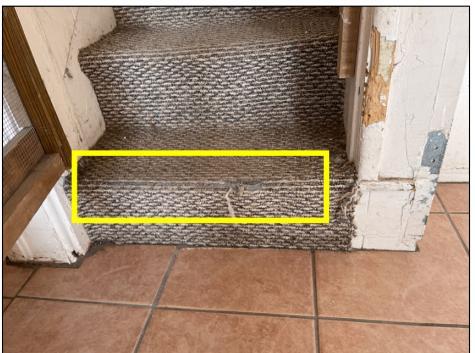
Damaged carpet flooring observed at bottom stair nose

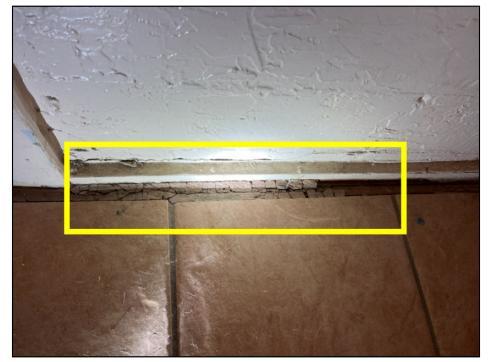
Cracked grout observed at south/east bedroom #1

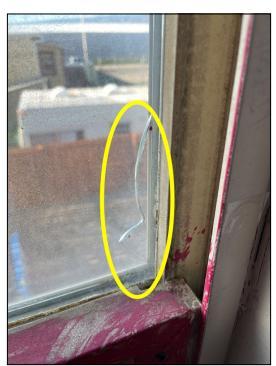
Damaged window pane in bedroom #2

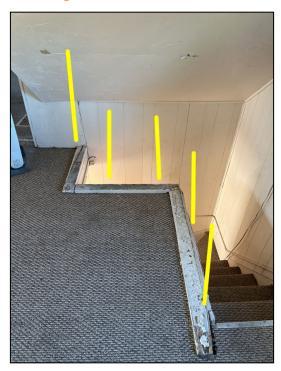
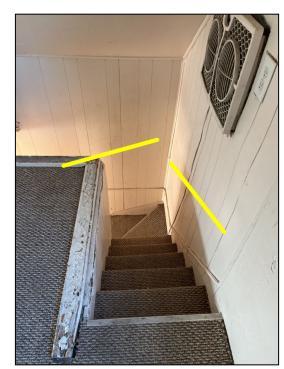
- SAFETY CONCERN: Railings are absent at upper level staircase(recommend repair).
 The upper level was not protected by a guardrail. Widely -accepted modern safety standards mandate that any walking surface 30 inches or more above grade should have a guardrail. I recommend installation of a guardrail by a qualified contractor

Absent guard rail at upper level staircase

Absent handrail at upper level staircase
