Precision Home Inspections, LLC

Property Inspection Report

LMNOP Road, Happy, CO 81500
Inspection prepared for: Inspector Daily
Real Estate Agent: Crystal Zimmerman - One Stop Realty

Date of Inspection: 8/20/2019 Time: 8:00
Age of Home: 26 Size: 6300
Weather: Clear

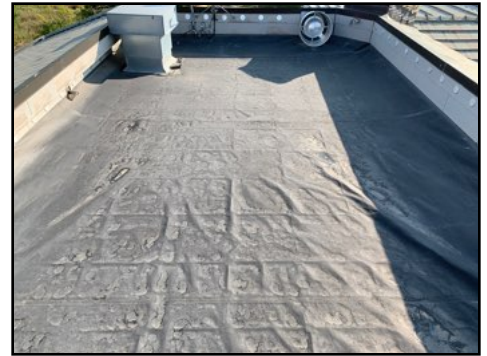
Rolled rubber roof covering

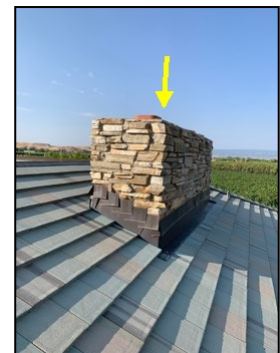
Stone chimney

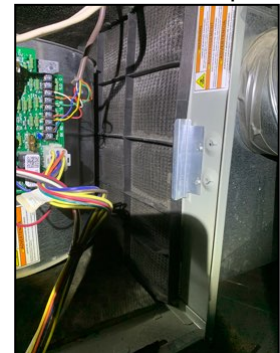
Crawlspace furnace filter at return air plenum, appeared clean

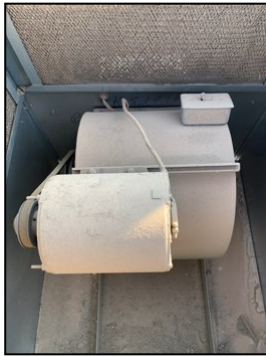
Inside evaporative cooler

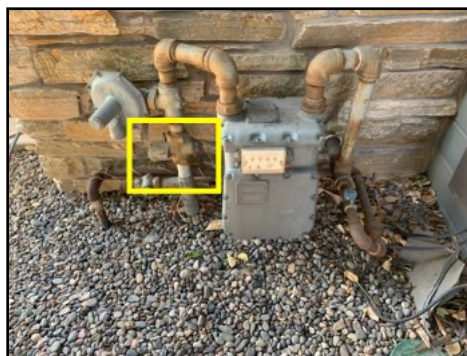
- The main gas shut-off was located at the gas meter located at the north of the home.
- FYI: Some occasional gas odor near the meter is normal. The gas system contains a pressure regulator that is designed to release gas into the outdoor air when pressure in the pipe rises above a certain level.

Main gas shut - off

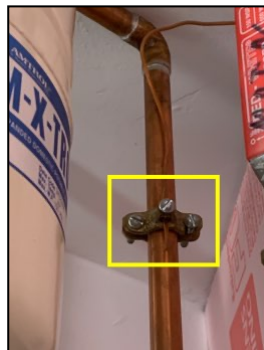
- The method for ground was not visible, a ground wire was noted exiting the panel. This is not uncommon, but the grounding method could not be verified.
- Primary grounding system is not fully visible.

Water pipe bond at water heater supply

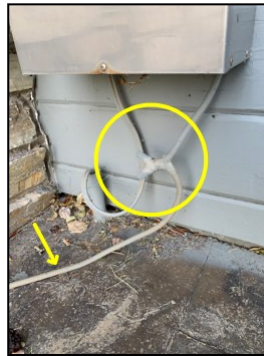
- Visible wiring appeared functional.
- Miscellaneous abandoned wiring visible in at north and east should be evaluated by a qualified electrical contractor to determine whether any wiring is still energized. Improperly terminated, energized wiring is a shock/electrocution hazard.
- Exposed wiring observed at north lower level. All exposed active wiring under 8' or at exterior of home is required to be in the appropriate conduit material (recommend repair by qualified licensed electrical contractor).

Exposed electrical wiring at north lower level

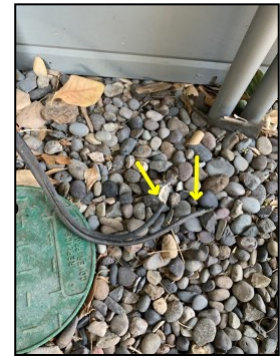
Abandoned electrical wiring at east aspect

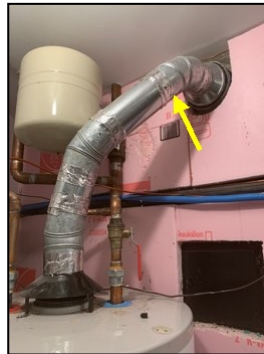
- Visible portions appeared functional with no discrepancies.
- Combustion air supply appeared typical per Mesa County code enforcement.
- Metal double wall chimney vent pipe
- NOT INSPECTED: The burn chamber of the water heater was sealed and the inspector was unable to evaluate its condition.

Water heater vent pipe exhausts into chimney flue

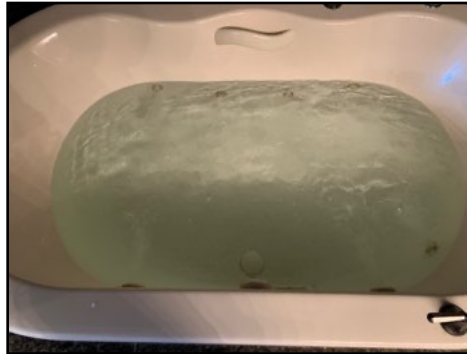
Jetted bathtub test

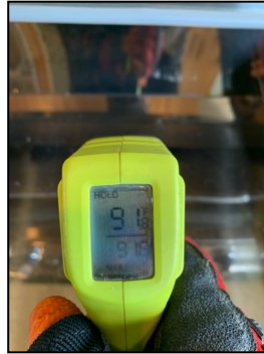
Left warming drawer

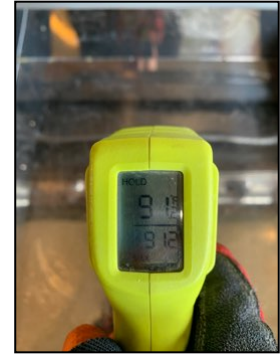
Right warming drawer

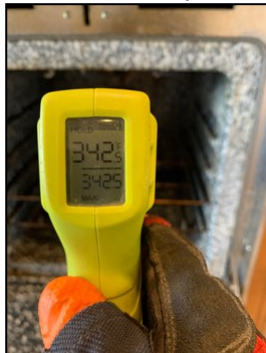
Upper oven

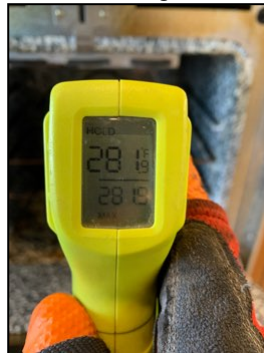
Lower oven

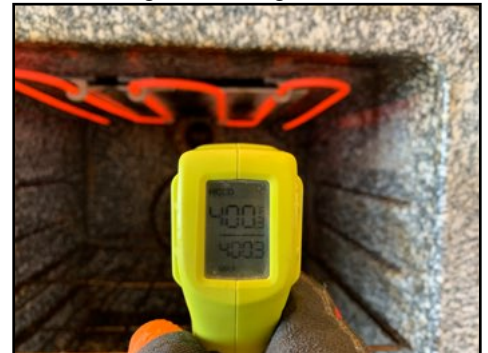
Upper broiler

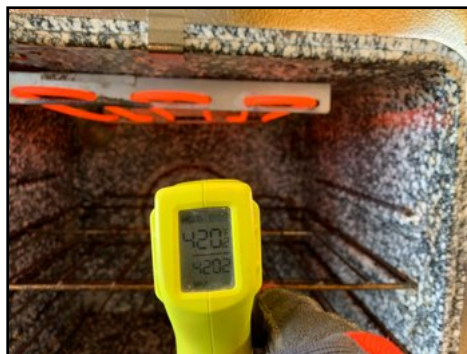
Lower broiler

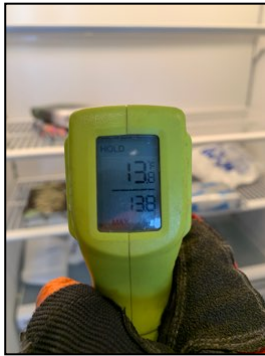
Freezer

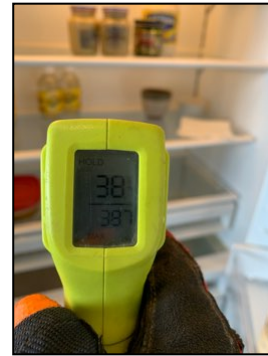
Refrigerator
