456 1st Street, Grand Junction, CO 81501 Inspection prepared for: John Smith Real Estate Agent: Always Available - Consider it Sold, LLC

Date of Inspection: 4/18/2022 Time: 8:00 Age of Home: 112 Size: 1245 Weather: Clear

Inspector: Ben Gare NACHI#18042422 Phone: 507-202-3333 Email: inspectgj@gmail.com inspectgj.com

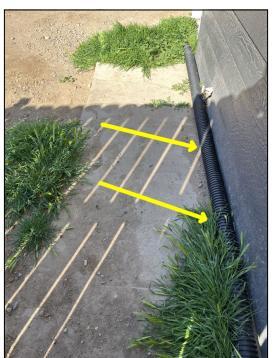
· Signs of settlement and improper drainage toward the home at areas of the walkways.

Settlement towards home at south walkway

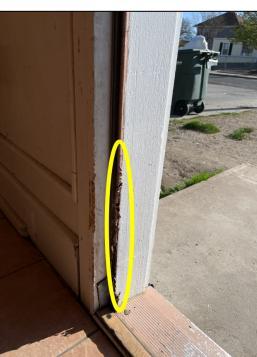
- Few deficiencies observed in the condition of the exterior doors at the time of the inspection. Notable exceptions will be mentioned in this report.
- · Door(s) loose when closed at Front entrance.
- · Weather stripping at Front entrance is damaged. I recommend repair as needed.
- FYI: All exterior painted surfaces should be annually examined and sealed, re-caulked and re-painted as needed.

Damaged weatherstripping at front entrance

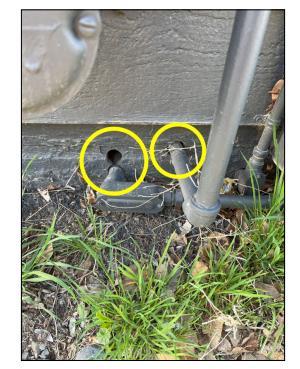
the exterior cladding at north

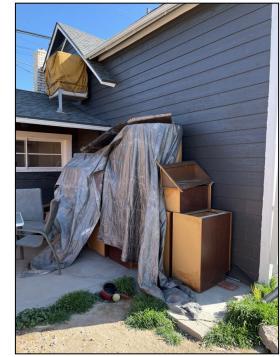
Personal storage limited visual inspection at west

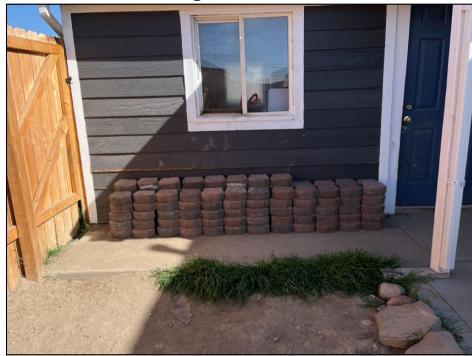
Personal storage blocked visual inspection at south/west

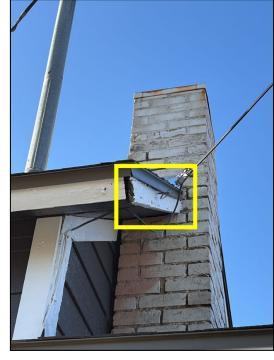
Damaged fascia observed at north/west upper level

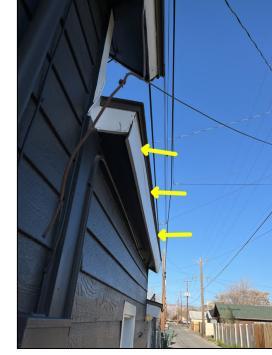
Loose fascia trim observed at north/west

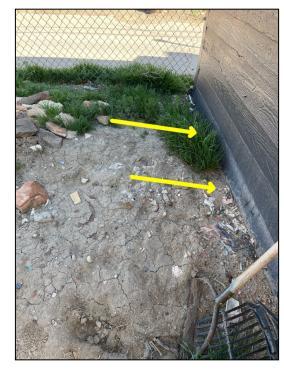
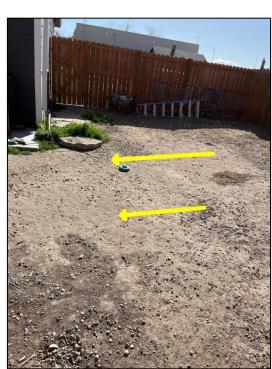
Negative slope towards home at west Negative slope towards home at south

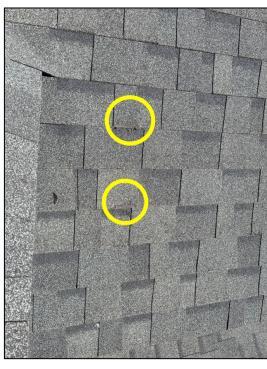
The asphalt shingle roof had minor visible damage which appeared to be made by workmen's equipment/foot traffic during warm weather.
I did not directly view the fasteners and disclaims responsibility for confirming proper fastening of the asphalt shingles. Fasteners used to connect asphalt composition shingles to the roof deck were not visible. At the time of the inspection the shingle adhesive strips were fully bonded. Because a fully bonded roof is the most important factor in the wind resistance of an asphalt shingle roof, breaking shingle bonds to view fasteners would constitute damage to the roof. Destructive testing lies beyond the scope of the General Home Inspection. Lack of damage to the roof indicated that fasteners were performing as designed.

Installation damage

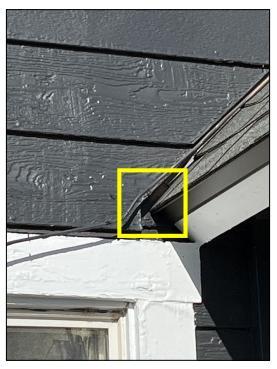
front entrance

· Roof edge flashing was damaged at areas around the home. I recommend repair by a qualified roofing contractor.

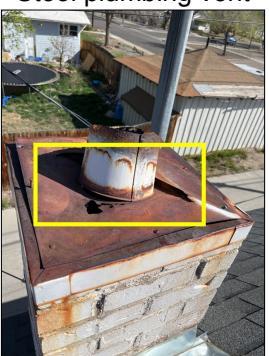
Page 13 Item: 5	Roof Penetrations	• The chimney cap had severe corrosion and appeared to be at the end of its useful life. Failure of the cap can allow moisture intrusion of the chimney structure that can damage the structure and create unhealthy conditions. I recommend that you consult with a qualified masonry contractor to discuss options and costs for chimney cap replacement.		
Page 14 Item: 6	Roof Drainage System	 Gutters were loose in areas and should be securely re-attached by a qualified contractor. Downspouts were loose in areas and should be securely re-attached by a qualified contractor. 		
Structural Componer	nts			
Page 16 Item: 1	Foundation Type	 In a basement or crawlspace, digging too close to the foundation footings can compromised the Cone of Compression. The Cone of Compression is the area of soil beneath a foundation that supports the weight of the foundation and the home structure above. This soil should remain undisturbed to avoid compromising its structural integrity. The profile of the weightbearing soil beneath the foundation is roughly cone-shaped, sloping down and out from the bottom corners of the foundation footing at an angle of approximately 45 degrees. This condition can lead to undermining of the foundation and loss of foundation support leading to structural failure in the affected areas. Inspectors should identify such areas and mention whether they observe signs of failure connected to this condition, and that the possibility for future damage exists. Recommend that the client consult with a structural engineer or qualified foundation contractor to determine the necessity, options and costs for stabilization. A crack visible at the foundation wall had a descending closure (wider at the top). This condition is typical of cracks caused by soil movement. Depending on the cause of soil movement, this condition may now be stable, or movement may continue in the future. I recommend that you consult with a structural engineer to more accurately determine the cause and the likelihood of continuing foundation damage from this condition.

Severely corroded chimney cap

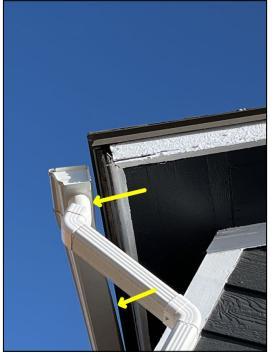
Loose gutter observed at south/west

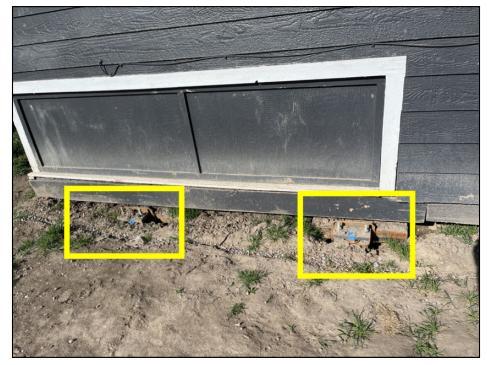
Page 17 Item: 3	Column - Piers - Beams	• Telescoping columns have been used as permanent structural supports. These supports are typically considered temporary (recommend review by qualified licensed framing contractor and repair as needed).		
Heating and Air Conditioning				
Page 20 Item: 2	Heating Systems	 According to the installed system pressure gauge, boiler pressure was above the generally accepted maximum limit of 30 pounds per square inch (PSI) at the time of the inspection. This is an unsafe condition. I recommend that boiler be shut down until it has been serviced by a qualified HVAC or plumbing contractor. According to the installed system temperature gauge, the boiler system temperature was

Adjustable piers observed beneath east bedroom #1

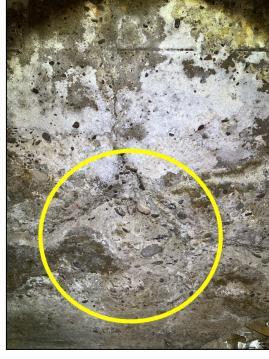
Severely deteriorated at north

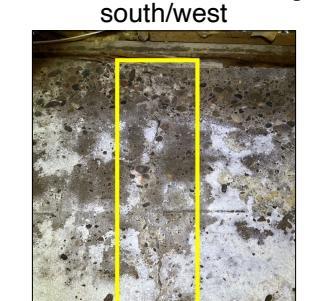
• A crack visible at the foundation wall had a descending closure (wider at the top). This condition is typical of cracks caused by soil movement. Depending on the cause of soil movement, this condition may now be stable, or movement may continue in the future. I recommend that you consult with a structural engineer to more accurately determine the cause and the likelihood of continuing foundation damage from this condition.

Descending closure crack observed at north

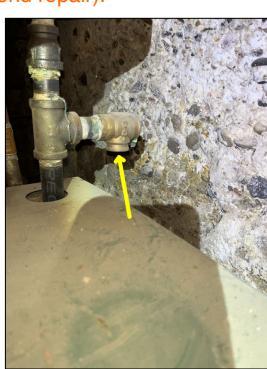
· SAFETY CONCERN: Temperature Pressure Relief (TPR) valve discharge extension pipe is absent (recommend repair).

Absent TPR discharge pipe

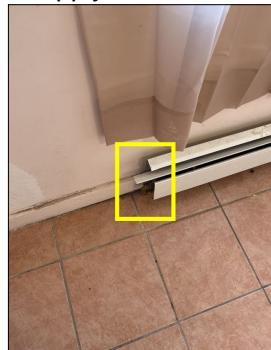
- Register temperatures observed to exceed greater than 25 degrees higher than ambient temperature.
 Evidence of damage at bedroom #1 register. I recommend repairs be made by a qualified contractor.
 Evidence of rusting at bathroom #1 register (possibly due to condensation from excessive moisture).
 Duct work was not fully visible.

Damaged register at bedroom #1

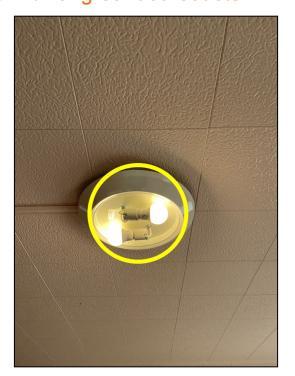
Absent bulb lens at living room

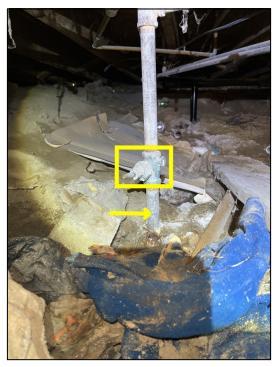
Main water service/shut - off at south crawlspace, handle is absent

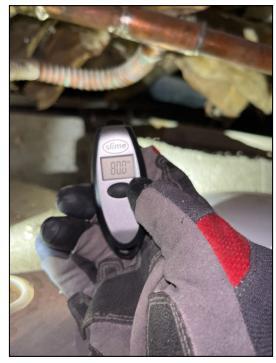
• FYI: A discrepancy was observed between expansion tank pressure and system pressure. There are several factors that apply to these settings and it is recommended to consult with a qualified licensed plumber about proper settings or adjustments to homes water pressure or expansion tank.

Expansion tank pressure

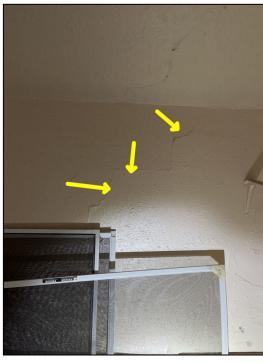
Unusual crack pattern at bedroom #2 closet

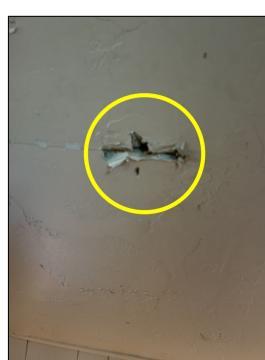
Drywall repair needed at top of staircase

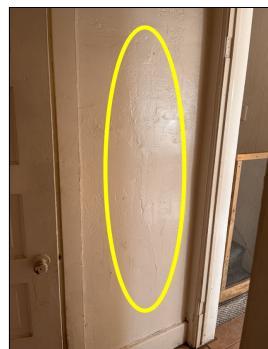
Unusual crack pattern at bedroom #1 Unusual crack pattern at west aspect of main hallway

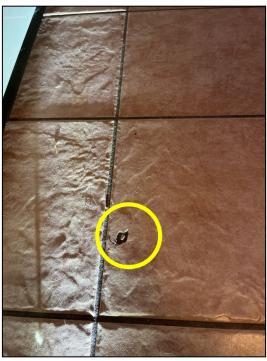
Chipped tile observed at south/west bedroom #1

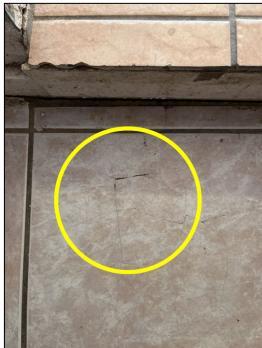
Cracked tile observed at east kitchen

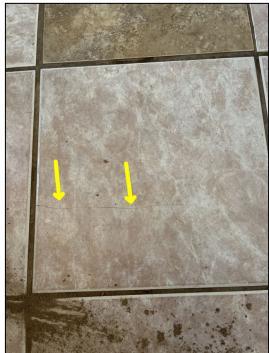
Cracked tile observed at north/west storage

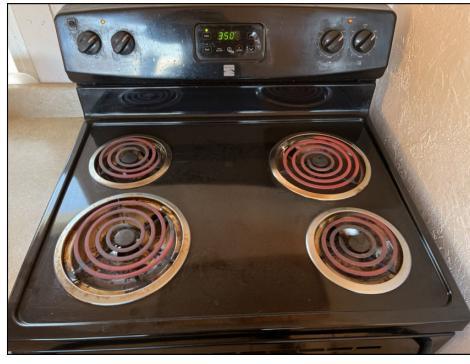
• Anti-tip bracket is missing from range installation. See label inside oven door. All free-standing, slide-in ranges include an anti- tip device and is essential in the safe operation of the range. It provides protection when excess force or weight is applied to an open oven door. Carried by home building centers.

- · Anti-Tip devises became a UL (Underwriters Laboratories) safety standard requirement in 1991.
- · SAFETY CONCERN: Free standing range missing anti-tip bracket/device. A qualified individual should install as needed.
